Dutch East India Company Shipbuilding

THE ARCHAEOLOGICAL STUDY OF
BATAVIA AND OTHER SEVENTEENTH-
CENTURY VOC SHIPS

Wendy van Duivenvoorde

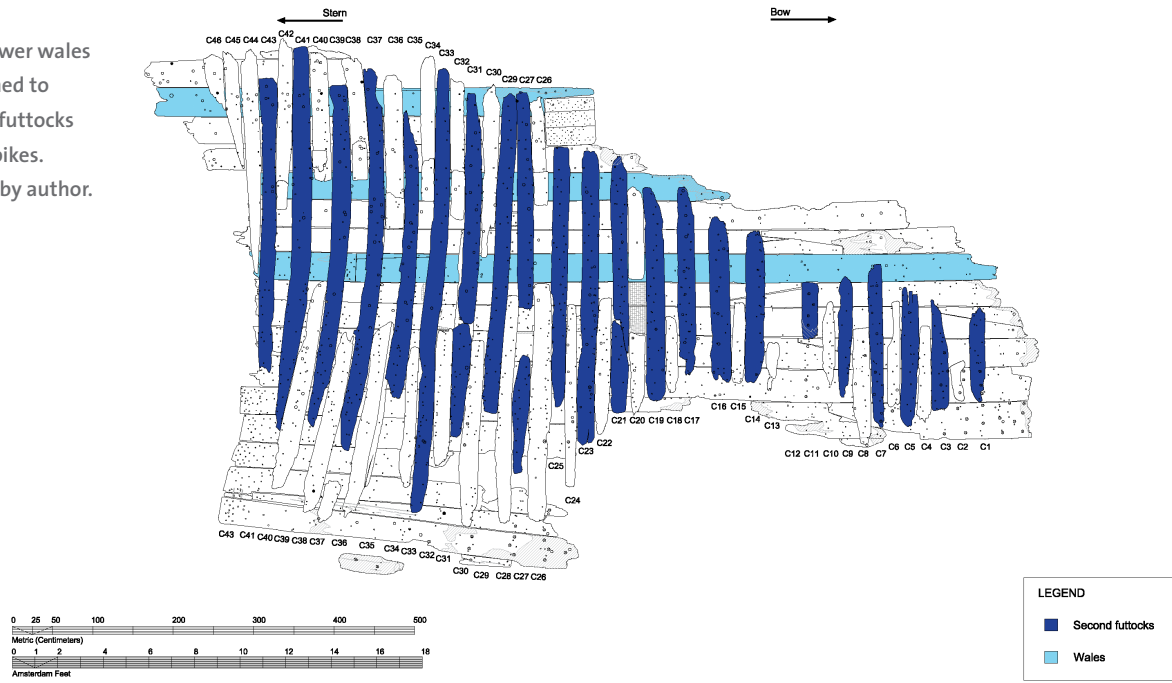
FIGURE 8-3.
Batavia's lower wales
 were fastened to
 the second futtocks
 with iron spikes.
 Illustration by author.

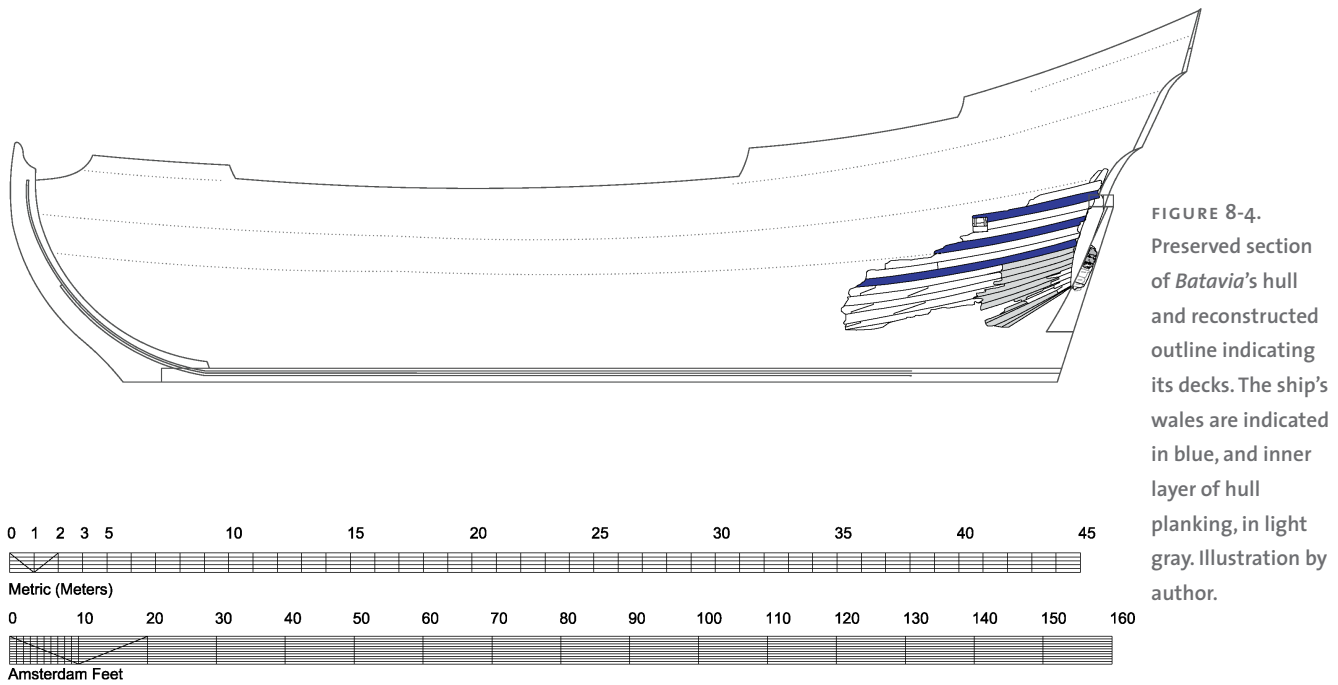
In the 1603 charter, the 130 ft ship was to be constructed with three frame wales of which the lowest two were to be 14 Amsterdam thumbs wide (36 cm), and their thickness had to correspond to two planks of the hull, whereas the third was supposed to be 1 Amsterdam ft (28.31 cm) wide and 4.5 Amsterdam thumbs (11.6 cm) thick. The three wales of *Batavia* all measure 36 cm in width. The lowest wale measures twice the thickness of the hull planking below and has a maximum thickness of 18 cm (7 Amsterdam thumbs). The second wale may have had the same dimensions, but its original thickness has not survived. The lower two wales, therefore, correspond to the 1603 VOC charter, but the third one does not. It is much wider than 1 Amsterdam ft, and its thickness is much greater than the 4.5 Amsterdam thumbs called for in the charter. It measures 19.3 cm (7.5 Amsterdam thumbs). Although *Batavia*'s third wale is placed at the lower gun deck over the surviving gun port, it can still be considered a frame wale because it was attached to the second futtocks, like the lower wales, and is associated with the lower gun-deck level and not the upper deck (fig. 8-4).
